**EMERGENCY SPILLWAY
PERFORMANCE AT SITE 39,
UPPER BLACK BEAR CREEK
WATERSHED, OKLAHOMA**

**ARS-S-109
March 1976**

EMERGENCY SPILLWAY PERFORMANCE AT SITE 39, UPPER BLACK BEAR CREEK WATERSHED, OKLAHOMA

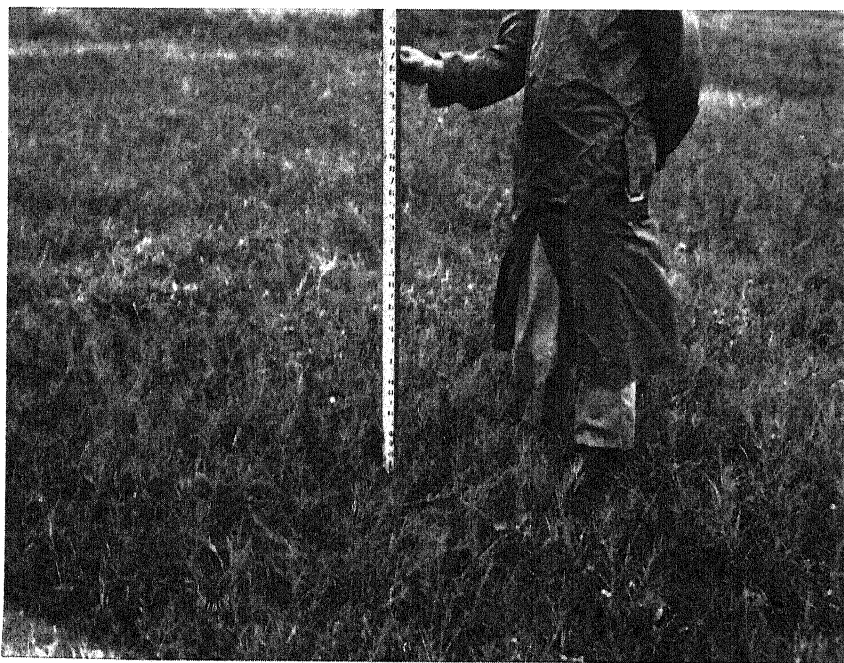
The grass in the spillway was in fair to good condition and was about 8 inches tall (fig. 3). Coverage was complete and fairly uniform except for a strip along the left side and a strip along the lower right side (facing downstream). The retardance class for the grass was estimated as being between a C and a D.²

FIGURE 3.—Bermudagrass cover on crest of emergency spillway.

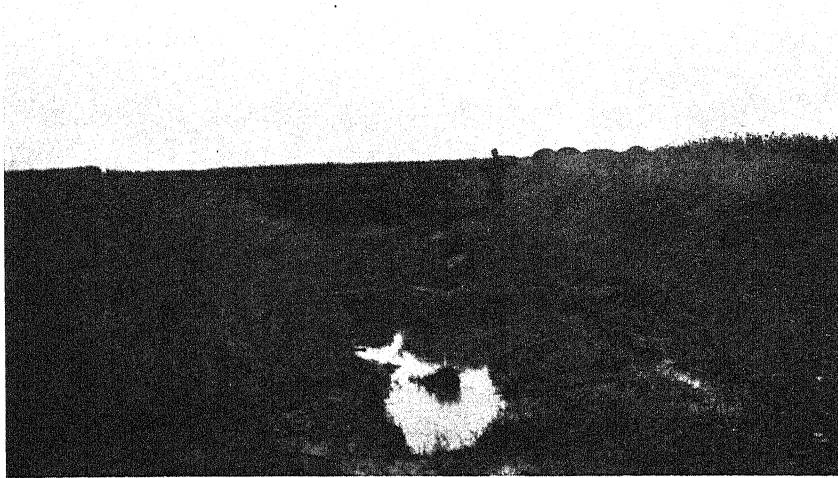
This normal flow did very little damage to the spillway except for forming some small gullies in areas which were probably deficient in grass cover before the storm.

FIGURE 4.—Gully about 100 feet long by 7 feet wide by 2 feet deep along left side of emergency spillway.

Erosion along the left side had formed a gully about 100 feet long by 7 feet wide by 2 feet deep (fig. 4). Upstream of this gully, a barren strip with some sheet erosion extended up to and over the spillway crest. There was no vegetation along the left side of the crest for a width of about 6 feet. Just outside the spillway and on the left bank at the crest was a capped, abandoned oil well. The area around the well also lacked vegetation, probably the result of effluent from the well (fig. 5).

The peak mean velocity of 7.7 feet per second in the spillway during the flow event is less than the permissible velocity of 8 feet per second for this site when the vegetation is in uniformly good condition, so no damage should have occurred to the spillway.⁴ Damage to the spillway was minor and occurred only in previously weakened areas.

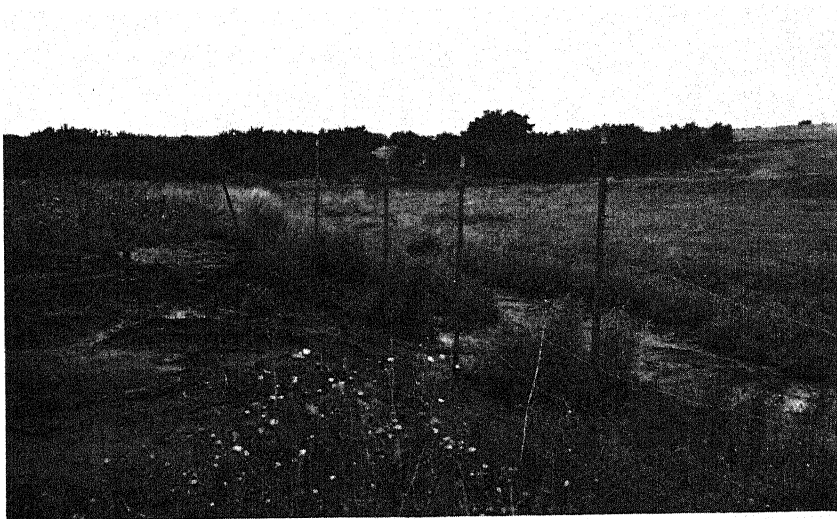
FIGURE 5.—Capped, abandoned oil well (to left) alongside crest of emergency spillway and barren strip (to right) on spillway crest.

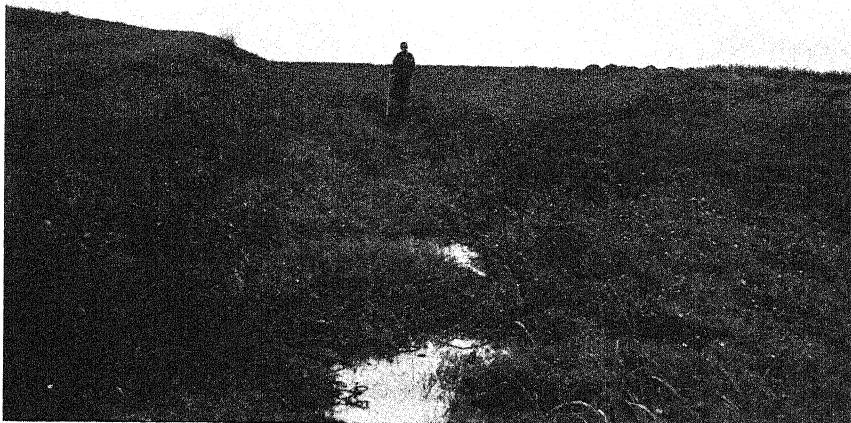
FIGURE 6.—Healed, small gully to right of lower end of emergency spillway.

A healed gully with minor erosion was observed along the right side of the lower part of the spillway (fig. 6). The old gully probably formed before a complete grass cover had been established. There is a possibility that this portion of the emergency spillway bottom was in a filled area. The "as built" plans for this structure showed that, in this vicinity, the spillway grade was actually built higher than was called for in the original plans. However, it is not known for certain that this was a filled area.
